Docket No. 217 – Development and Management Plan Inspection

Northeast Utilities Service Company Certificate of Environmental Compatibility and Public Need for the construction of a 345-kV electric transmission line and reconstruction of an existing 115-kV electric transmission line between Connecticut Light and Power Company's Plumtree Substation in Bethel, through the towns of Redding, Weston, and Wilton, and to the Norwalk Substation in Norwalk, Connecticut.

Date: July 19, 2006

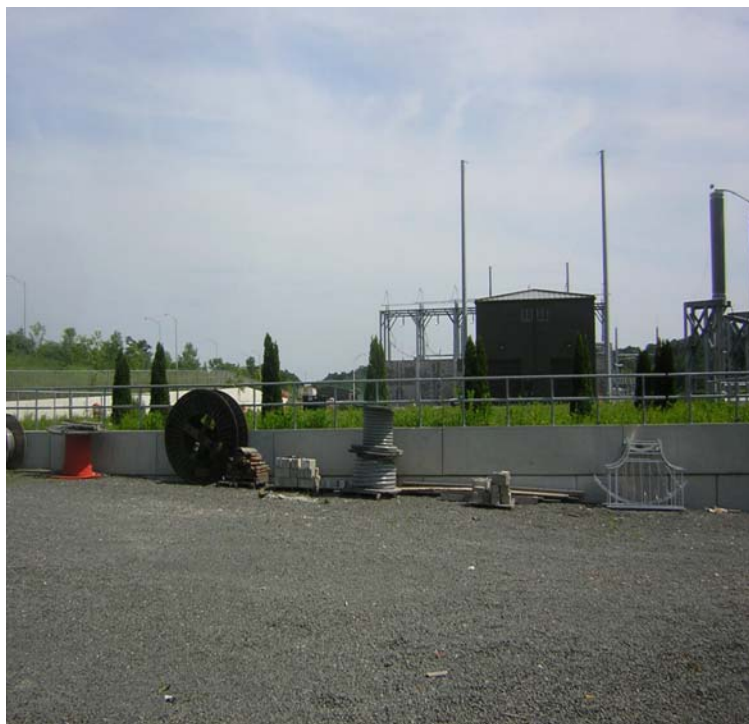
Areas of Inspection	Observation	Recommended Action	Corrected Action
Inland Wetland and Watercourse encroachment and mitigation	- Vegetation continues to grow well along the original overflow channel as well as in the landscaped area near the GIS building. 7/19/06.	- None at this time. 7/19/06.	-N/A
Vegetative clearing limits (including trees to save or danger trees noted)	-The riverbank to the north of site could use some vegetative growth. 5/17-7/19/06	- None at this time. Continue to monitor and consider adding seed if feasible. This is likely overhead jurisdiction. 5/17-7/19/06	-N/A
Dewatering	-Construction dewatering should no longer be occurring on site. 7/19/06.	-None at this time. 7/19/06.	-N/A.
Blasting	- Not applicable	- None at this time.	-N/A
Spills and Material Storage	- Most heavy equipment is removed from the site. 7/19/06.	In general: - Continue to keep all vehicles maintained well (i.e. no apparent fluid leaks) if they will be used or stored on site. - Report spills to the office immediately, even if they are being controlled.	-N/A

Norwalk Substation: Photo on the left shows the vegetative cover at the hydroseeded and landscaped area near the GIS building. Plumtree Substation: Photo on the right shows an overview of the yard including the recently constructed work. 7/19/06

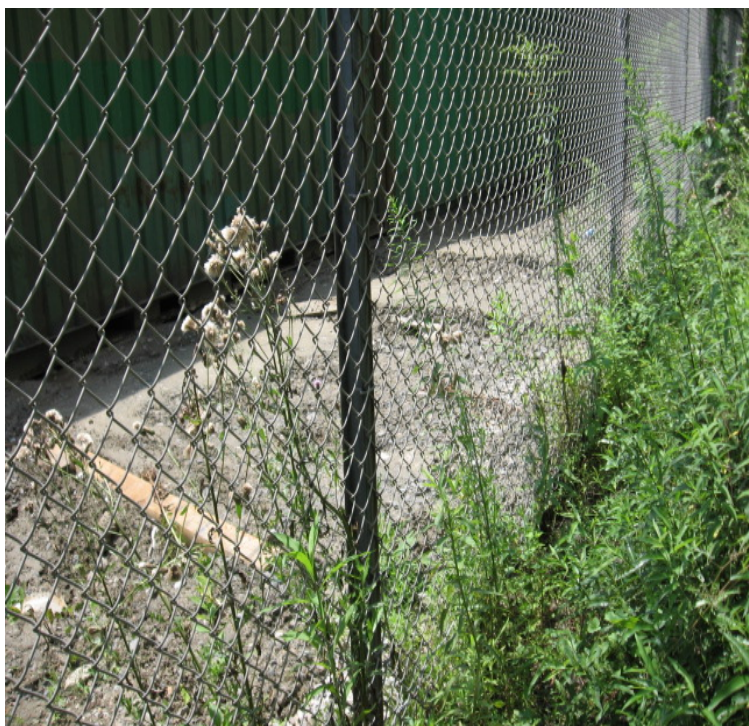
Erosion and Sediment Controls (includes inspection within 24 hours of a storm event)	<ul style="list-style-type: none"> - The site has been graded on an even level to the perimeter stone berm towards the rear of the site. 7/19/06 -A few stockpiles remain but are contained internal to the site. The rear of the site was graded and placed with stone. 7/19/06. 	<ul style="list-style-type: none"> - The berm must remain maintained as sediment control. It may need to be built up with stone in order to filter effectively. 7/19/06 -Continue to monitor. 7/19/06. 	<ul style="list-style-type: none"> - Needs attention -N/A
Inland Wetland and Watercourse encroachment and mitigation	<ul style="list-style-type: none"> - Wetlands are located around the outskirts of the substation yard. 7/19/06 	<ul style="list-style-type: none"> - Maintain perimeter berm. Vegetation adjacent to the yard is thick and helps filter run-off. 7/19/06. 	<ul style="list-style-type: none"> N/A.

Photo on the left shows where soil within the

yard was graded at an even level with the perimeter stone berm. The berm may need to be built higher to filter run-off effectively. Photo on the right shows the graded area at the rear of the site where the settling basin used to be. 7/19/06
